Device **TC29x**
Marking/Step **ES-BC, BC**
Package **see Data Sheet**

This Errata Sheet describes the deviations from the current user documentation.

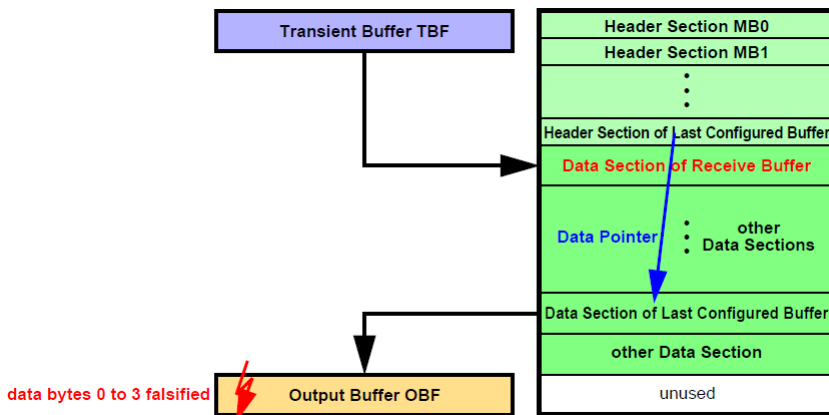
Figure 1 Message buffer transfer from Message RAM to OBF

When the message buffer has its payload configured to maximum length (PLC = 127), the OBF word on address 00h (payload data bytes 0 to 3) is overwritten with unexpected data at the end of the transfer.

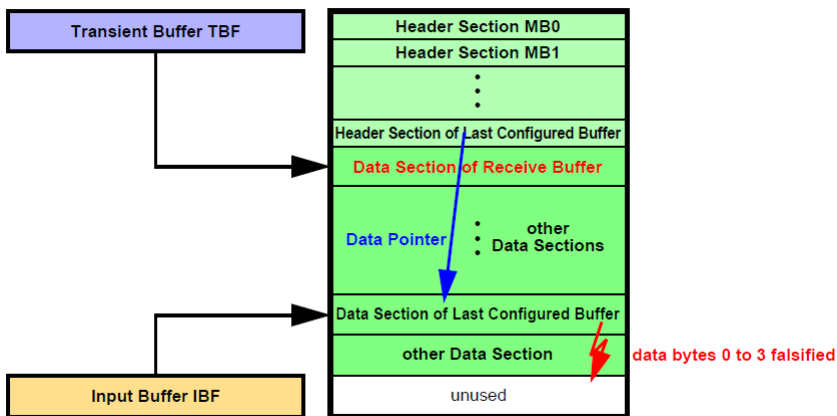
Figure 2 Message buffer transfer from IBF to Message RAM

After the Data Section of the selected message buffer in the Message RAM has been written, one additional write access overwrites the following word in the Message RAM which might be the first word of the next Data Section.

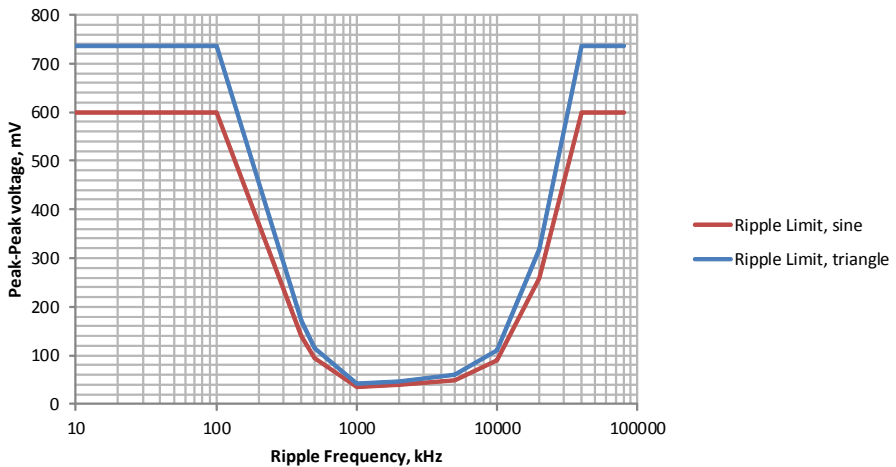
Figure 11 Ripple Voltage vs. Frequency Characteristic

The internal back-up clock is sensitive to specific power supply voltage disturbance/ripple caused by a voltage ripple intrinsic to DC-DC converters. Specific conditions such as insufficient filtering of the ripple may lead to improper behavior of the start-up scheme of the back-up clock, and thus stuck-at state during the start-up of the microcontroller until this condition is removed.

The diagram reflects acceptable ripple level during the cold start of the microcontroller at the respective VDDP3/VEXT/VEVRSB supply of the PMS subsystem, depending on the device and package type, as shown in the following table.

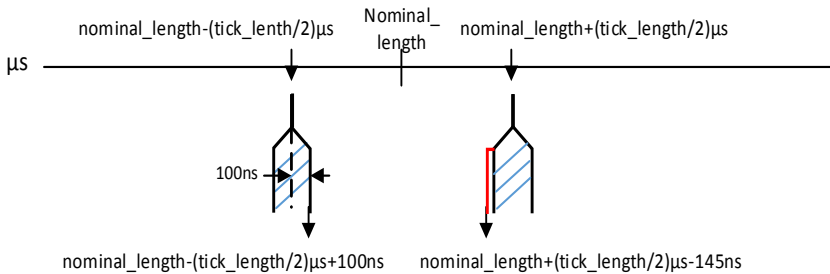
Figure 13 SENSITIVITY TOLERANCE of this Design Step

- The lower border is $\text{nominal_value} - (\text{tick_length}/2) \mu\text{s} + 100 \text{ ns}$
- The upper border is $\text{nominal_value} + (\text{tick_length}/2) \mu\text{s} - 145 \text{ ns}$.

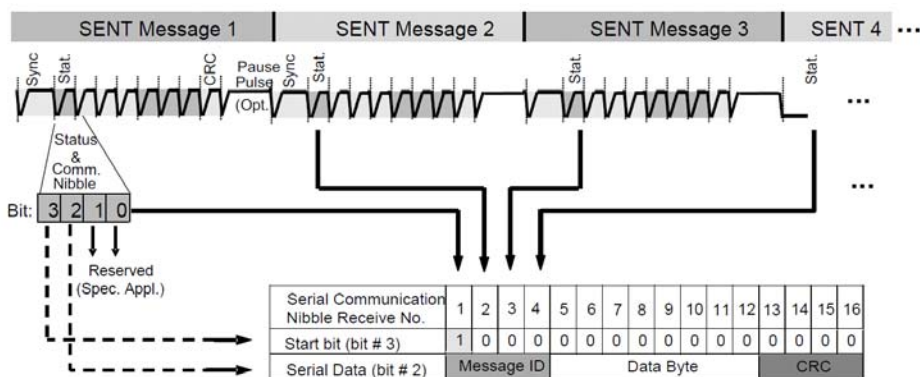
Figure 14 Short Serial Message, Serial Data Encoding over 16

Figure 14 shows a corrected version of this figure.
