Device **TC29x**
Marking/Step **ES-BC, BC**
Package **see Data Sheet**

This Errata Sheet describes the deviations from the current user documentation.

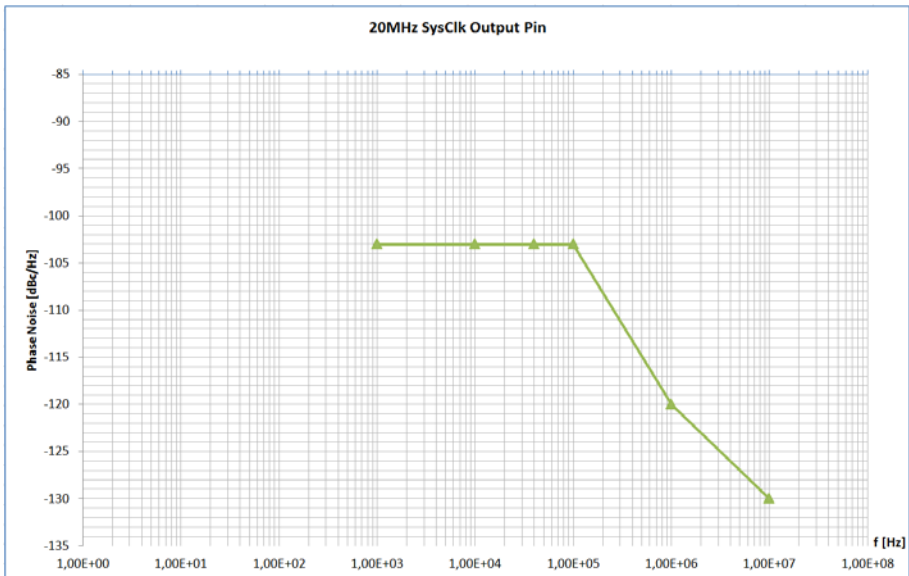
Figure 5 Phase Noise Density on SysClk Output Pin

The diagram below shows the phase noise density on the SysClk pin when no application pattern but only the HSSL/HSCT subsystem is running:

When designing the PLL for an HSSL/HSCT ASIC, the values for I_{PN} and J_{ABS20} above and ultimately $BER_{20} = 10^{-12}$ can be achieved with the following recommendations:

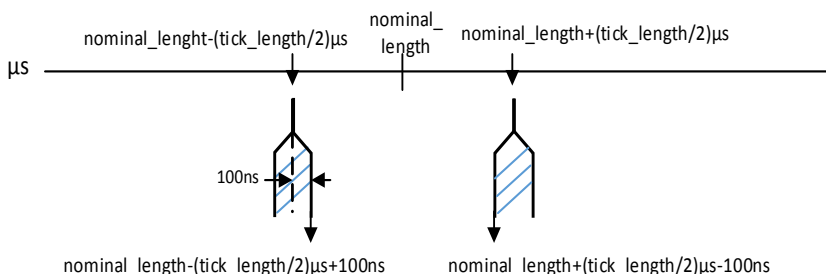
Figure 12 SENT Standard Tolerance

The length of a nibble in the SENT protocol determines the value of this nibble. For each value this length can vary, but it has to be at least inside a given range. This range is given by the SENT standard.

- The lower border is $\text{nominal_value} - (\text{tick_length}/2) \mu\text{s} + 100 \text{ ns}$
- The upper border is $\text{nominal_value} + (\text{tick_length}/2) \mu\text{s} - 100 \text{ ns}$.

In this design step the range is delimited as follows:
